Maintenance News

14

Spring
1979

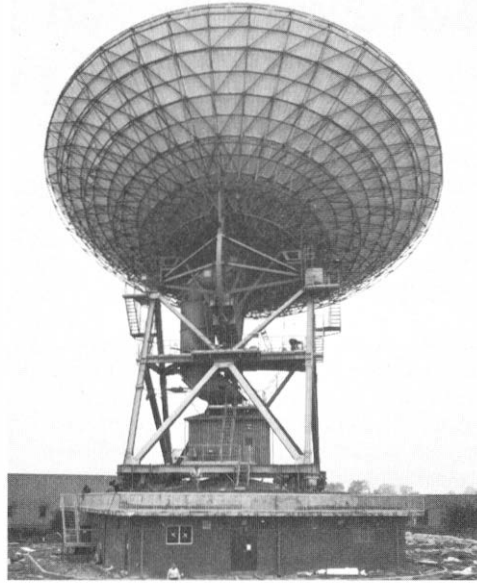
Madley's first Aerial System with a view of the beam waveguide and the relatively lightweight backing and support structure.

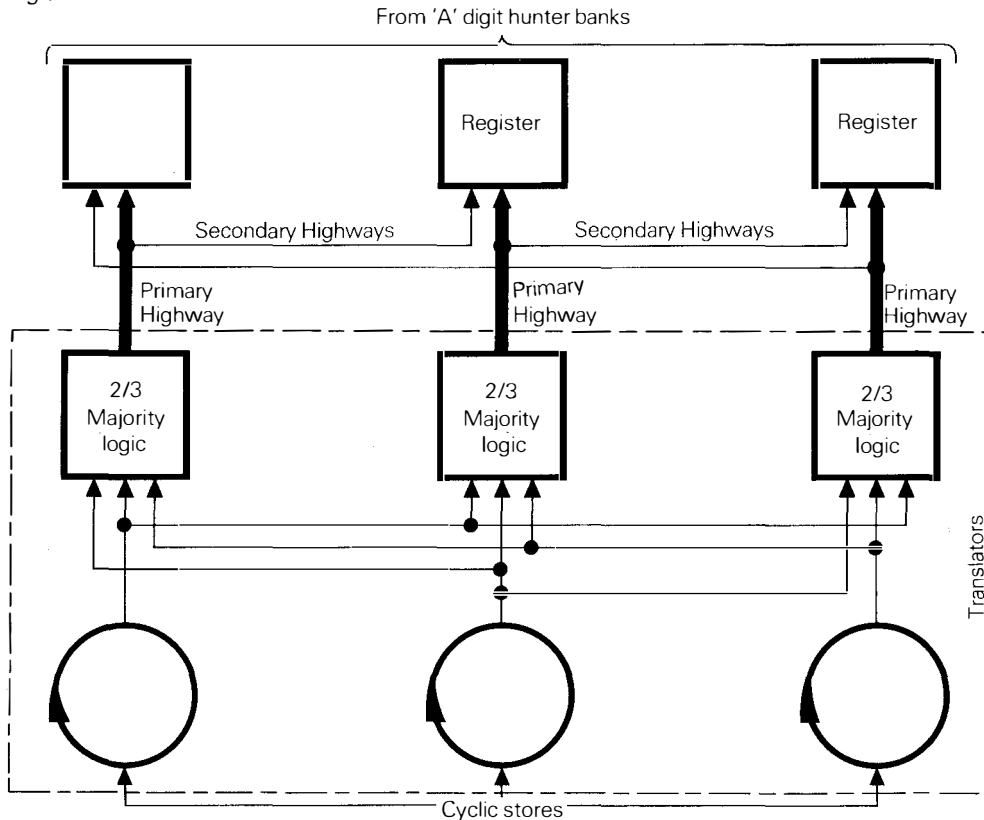
Fig 1

Basic block diagram of the Type 13 R/T

Each containing up to 1999 address and translation codes. The information in each store is identical except for that in store address zero.

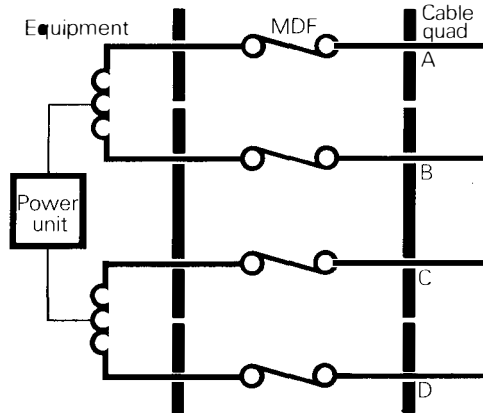
Fig 1 Power feed arrangements at terminal stations (simplified)

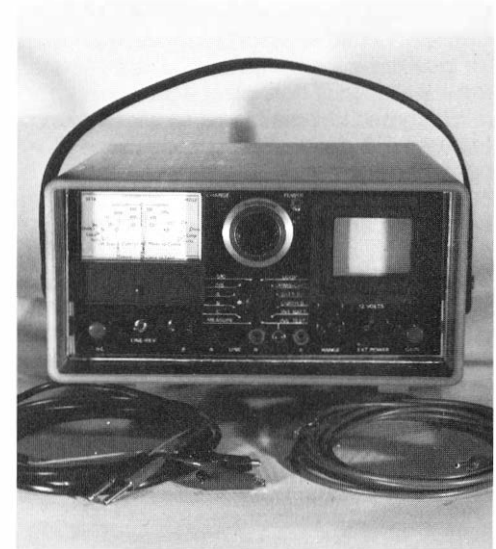
Multimeter

MOLE has been specifically designed to give resistance and voltage indications similar to the ranges of the tester SA 9083 as used by Faultsman Jointers.

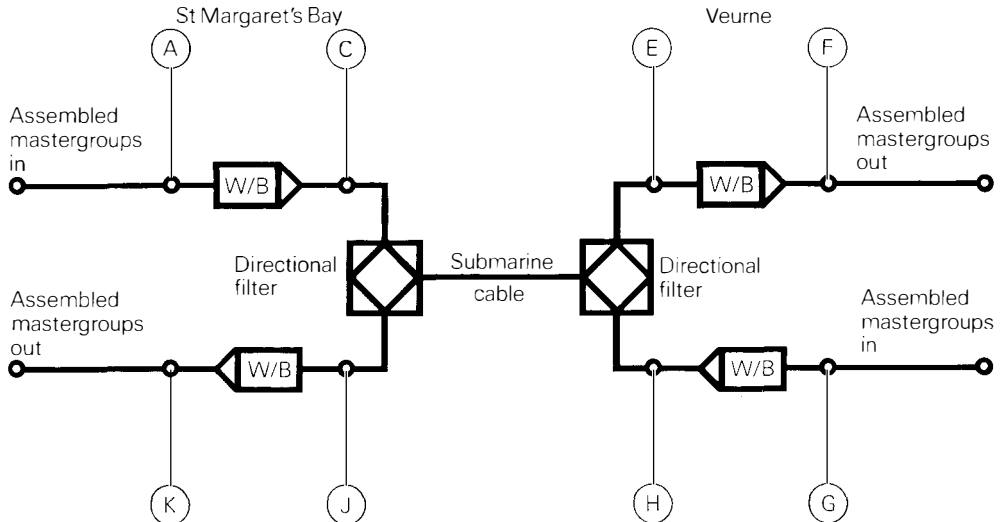
Block schematic of test points
St Margaret's Bay – Veurne System

compensating. Changes of sea temperature alter the repeater gain, overcoming the effect of the changes in cable attenuation. The new computerised method is able to plot graphs to show how effective the repeaters are in achieving this aim. In practice some cycling will be observed due to uncompensated end-sections and other residual effects, but these are corrected in the terminal stations using VTEs and attenuators. Because the measuring points for this particular test are on the submerged cable side of the correction networks, the shape of the graphs is not affected by the terminal changes.

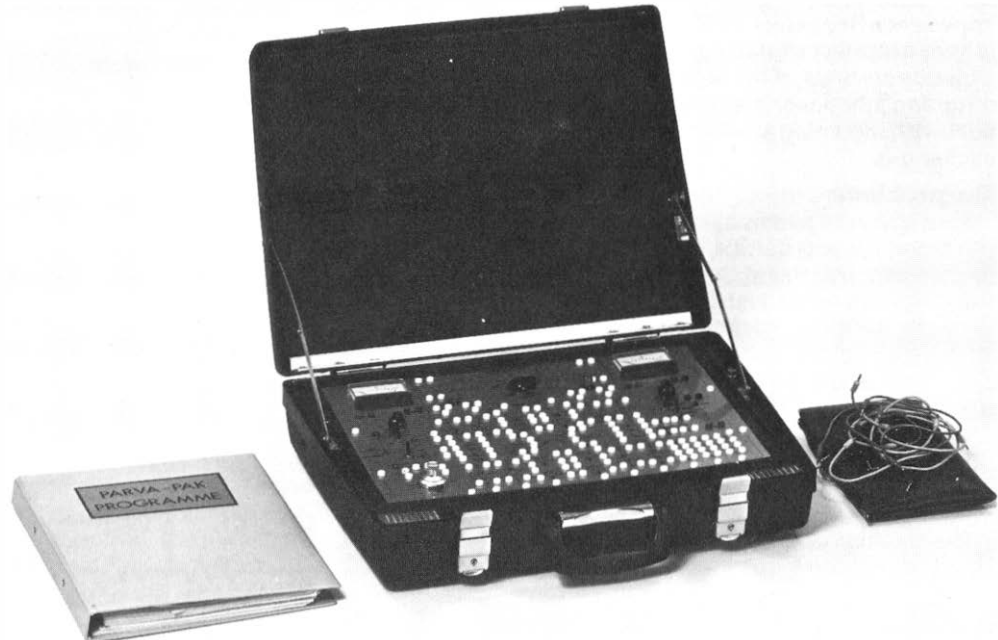
Fig 1 Complete course package

Fig 1 shows the resulting prototype, and fig 2 the component symbols with their associated jack-in terminals. All components are mounted under the face plate, along with the battery power supply, and can be interconnected with flexible plug-ended leads. The meters allow simple tests to be made. The face plate, components and plug-in leads are contained within a double-sided executive briefcase, which has an automatic power cut-off on closing.
