Maintenance News

23
Autumn/Winter
1983

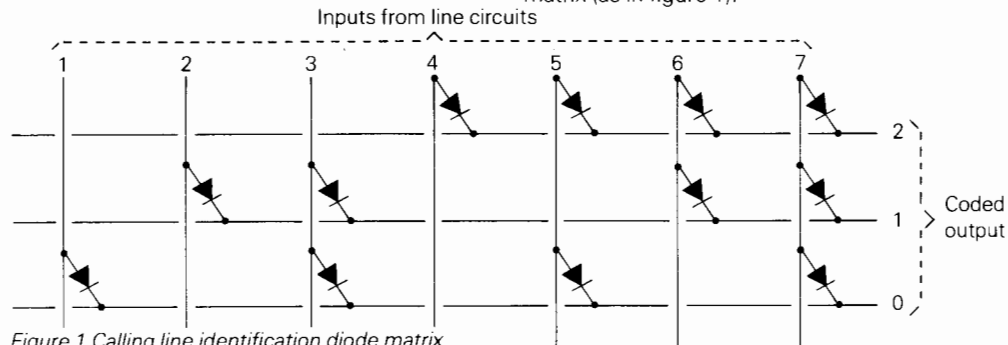
Figure 1 Calling line identification diode matrix

But this design raised problems, in that by logging at a common concentration point available to more than one exchange line, the calling line identity (CLI) is not known. A revised design overcomes this by using the fact that there is a continuous metallic path from the concentration point to the line circuit – the P-wire. If a signal is injected on to the P-wire at the first selector, and each line circuit P-wire is connected to a receiving circuit through a component matrix, the identity of the P-wire can be obtained by decoding the output of the matrix (as in figure 1).

Obviously, the P-wire was not intended for this use and it is essential to ensure that the CLI signals applied do not interfere with the normal operation of the exchange and that the conditions normally occurring on the P-wire do not affect the operation of CLI. The CLI signals used have been selected to fall outside the range of voltage and/or timing of the exchange signals.

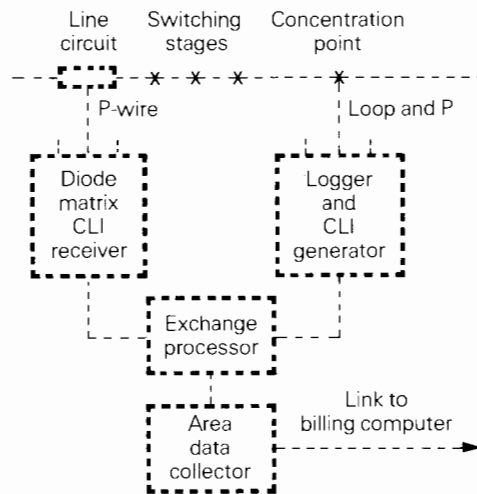
Figure 2 Call logging system schematic

The accuracy and security of recorded data in the call logging system has been given a high priority in the design. Much of the hardware and all of the storage is duplicated, with comparisons made between the two halves to detect errors. Very secure data transfer protocols are used between the local exchange

and the Area Data Collector (ADC) and between the ADC and the billing computer. Back-up storage will be provided at both sites in case of equipment or link failure.

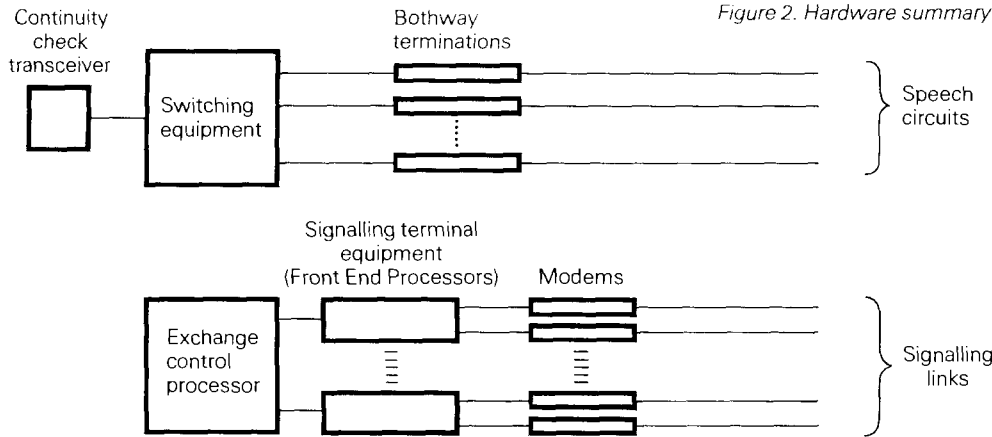
Figure 2. Hardware summary

The hardware required in a typical stored program control exchange is shown in figure 2. Link synchronisation and error-rate monitoring is usually performed by a front-end processor. The main exchange processor handles call processing, signalling network control, maintenance functions and so on.

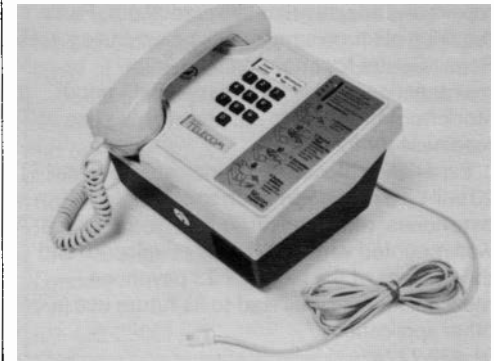
Coin Telephone 23

The telephone is plug-ended and can be free-standing, screwed to a shelf, or secured by a chain, to give flexibility of movement with a measure of security.

Unlike the new range of electronic public payphones, the CT 23 has no self-diagnostic or automatic reporting facilities. A faulty CT 23 normally receives maintenance attention on-site, rather than a complete change of mechanism, as was the case with its pay-on-answer predecessor. This is achieved by use of a field maintenance pack, containing instructions, tools, and hardware necessary to effect on-site repair.

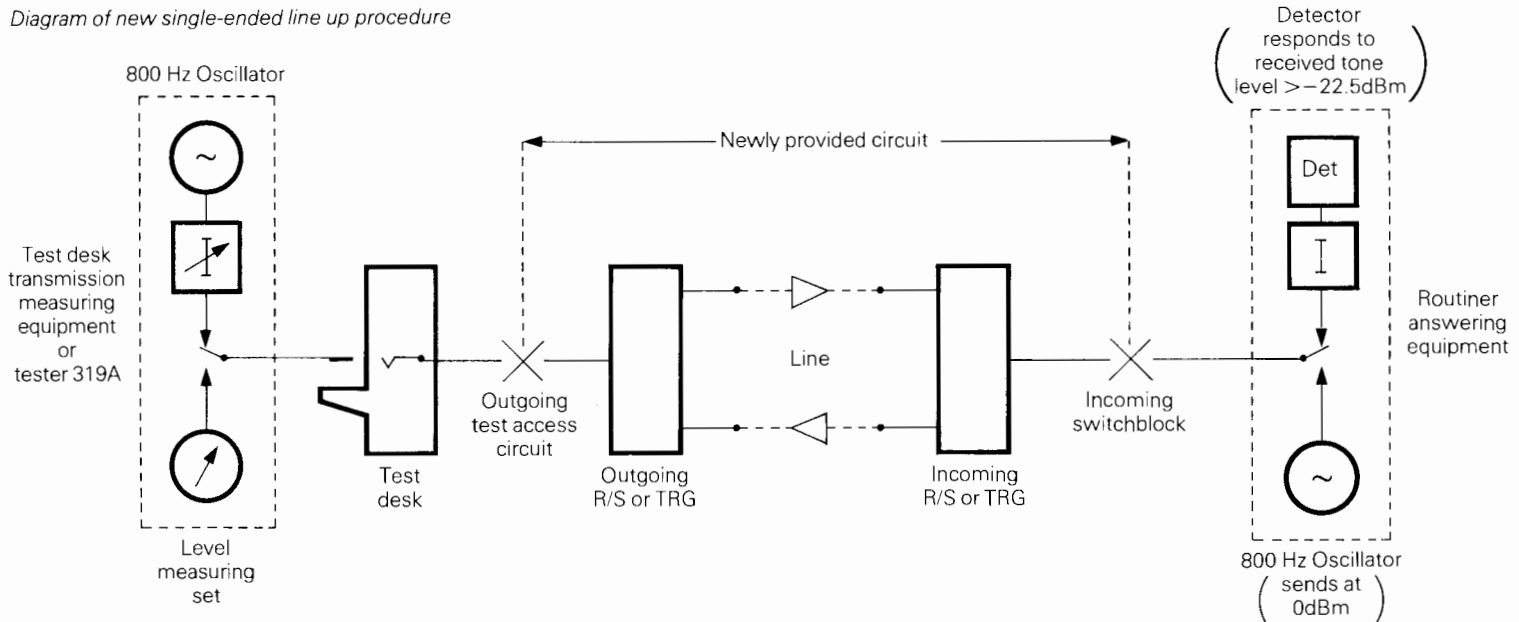
The RA equipment at the incoming exchange is accessed over the newly-provided circuit under test. At the outgoing exchange, a low-level 800Hz tone is applied to the circuit through a variable attenuator so that it is received by the RA equipment detector below its triggering level of -22.5dBm . The variable attenuator value is then decreased in 1dB steps (to increase the sending level) until the tone is raised just sufficiently to trigger the RA equipment detector. This then causes the RA equipment to return a 0dBm 800Hz tone to the outgoing exchange where it can be measured on the test desk Level Measuring Set. The transmission loss of the circuit can now be

Diagram of new single-ended line up procedure

As the fixed values of the triggering level and oscillator output level of the RA equipment are used to determine the transmission loss of the circuit in both directions, it is essential that they are within specified tolerances – otherwise, circuits may be put into service which are outside transmission limits. These could then cause transmission difficulties, which would have to be investigated and corrected by maintenance staff.

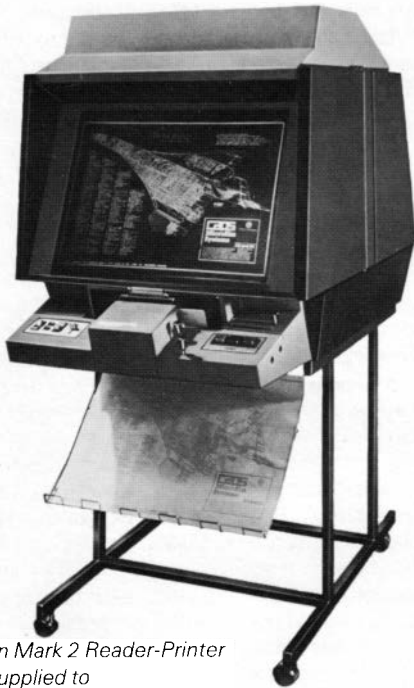
*Orion Mark 2 Reader-Printer
as supplied to
Area Repair Centres*

immediately for use at the electronic repair bench. Within the next 12 months, all area repair centres will be supplied with a reader/printer of the type illustrated, as soon as accommodation space has been earmarked in the ARC, but priority will be given to those ARCs repairing Monarch units.
(01-432 2806)
